Asbestos Survey for

London Borough of Waltham Forest

Selwyn Junior School
Cavendish Road
Chingford
London
E4 9NG

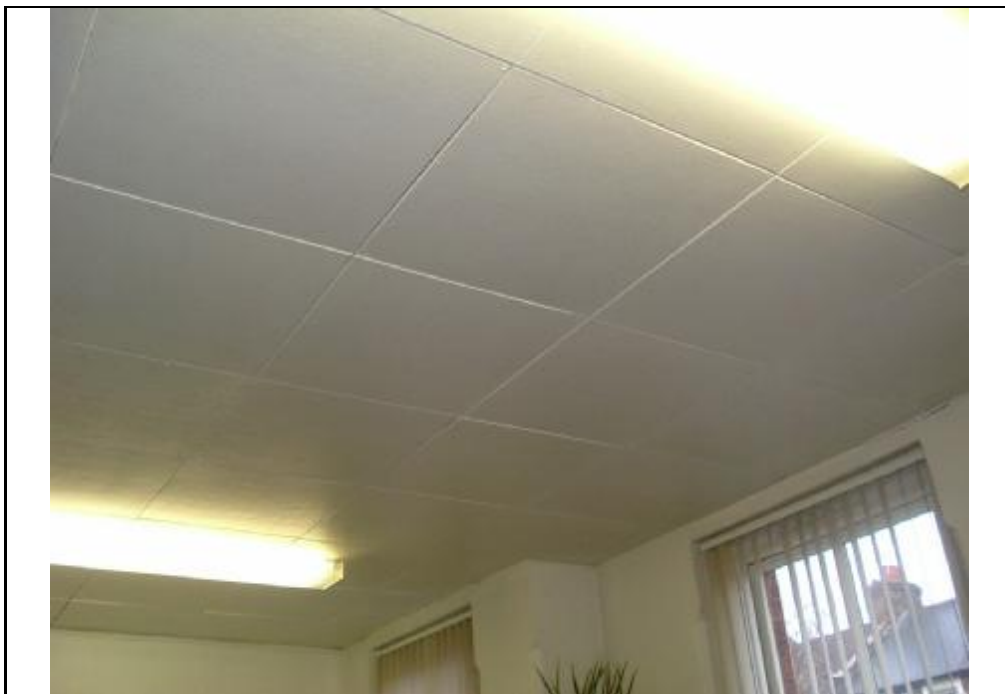
Material Comments: Asbestos Paper (ceiling tile lining)

Action: Label and Manage

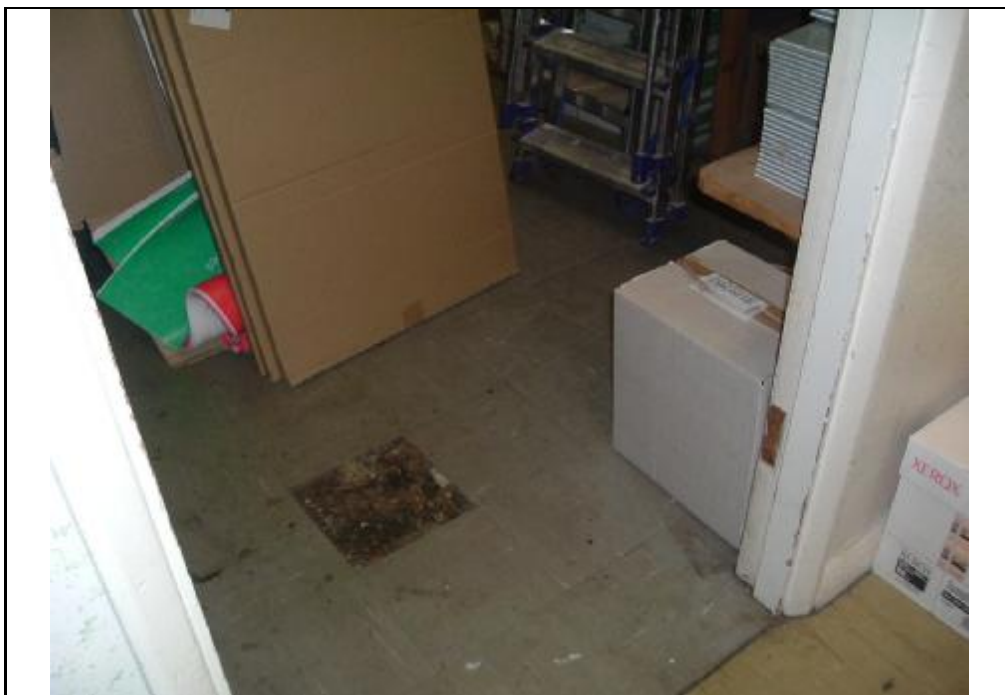
Material Risk Score: 4
Material Risk Band: Very Low Risk
Priority Risk Score: 5

Material Comments: Asbestos Floor Tiles

Action: Manage only

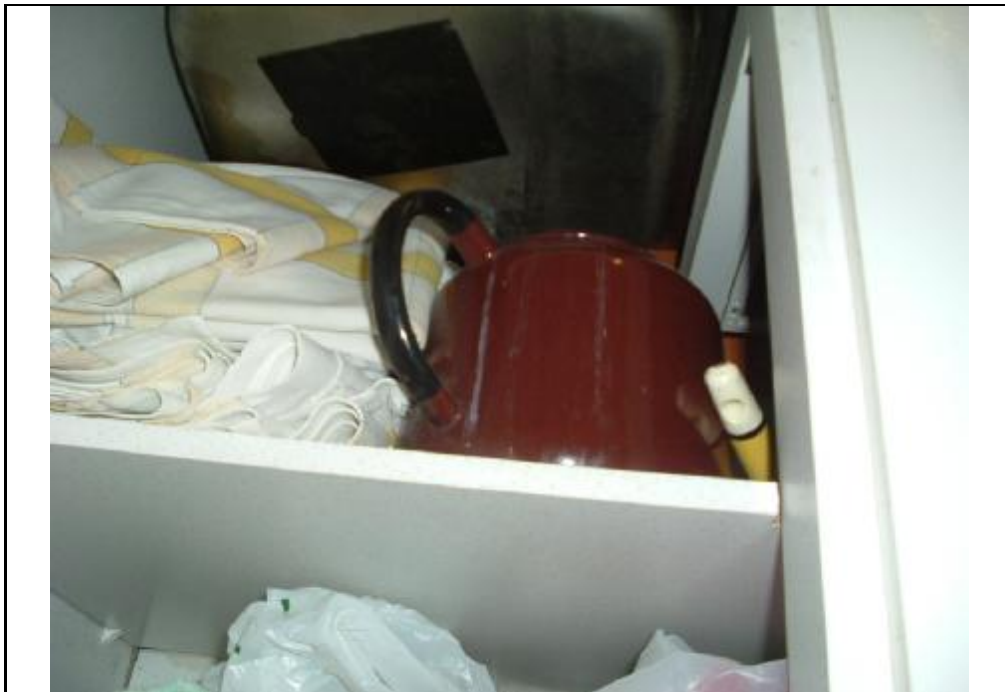
Material Comments: NADIS - Bitumen Pad (beneath sink)

Action: No Action Required

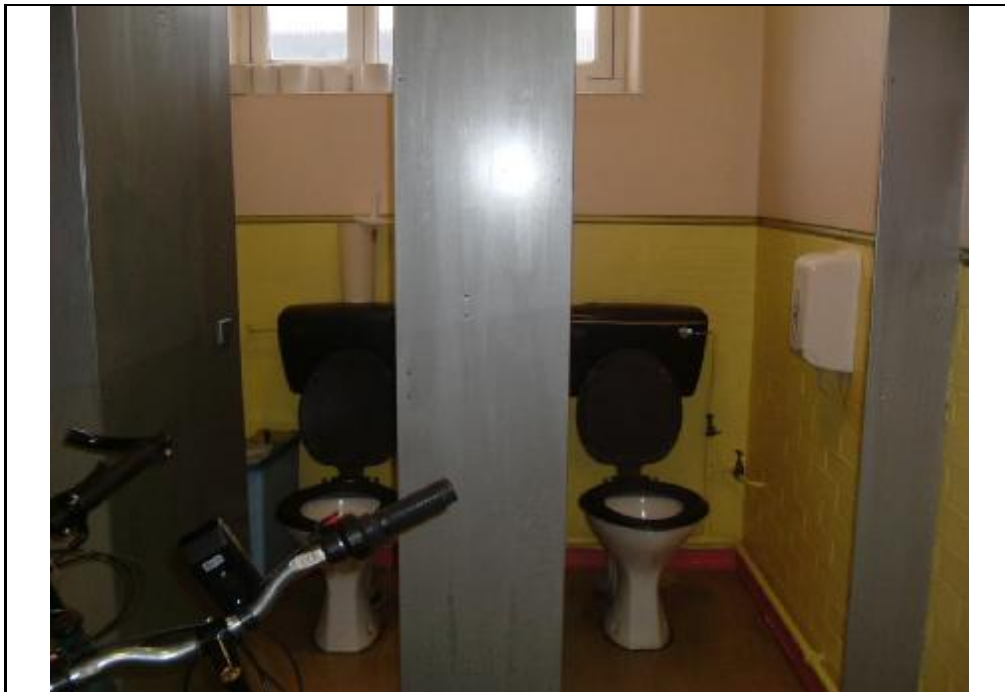
Material Risk Score: 4
Material Risk Band: Very Low Risk
Priority Risk Score: 3

Material Comments: Asbestos Toilet Cisterns (x2)

Action: Label and Manage

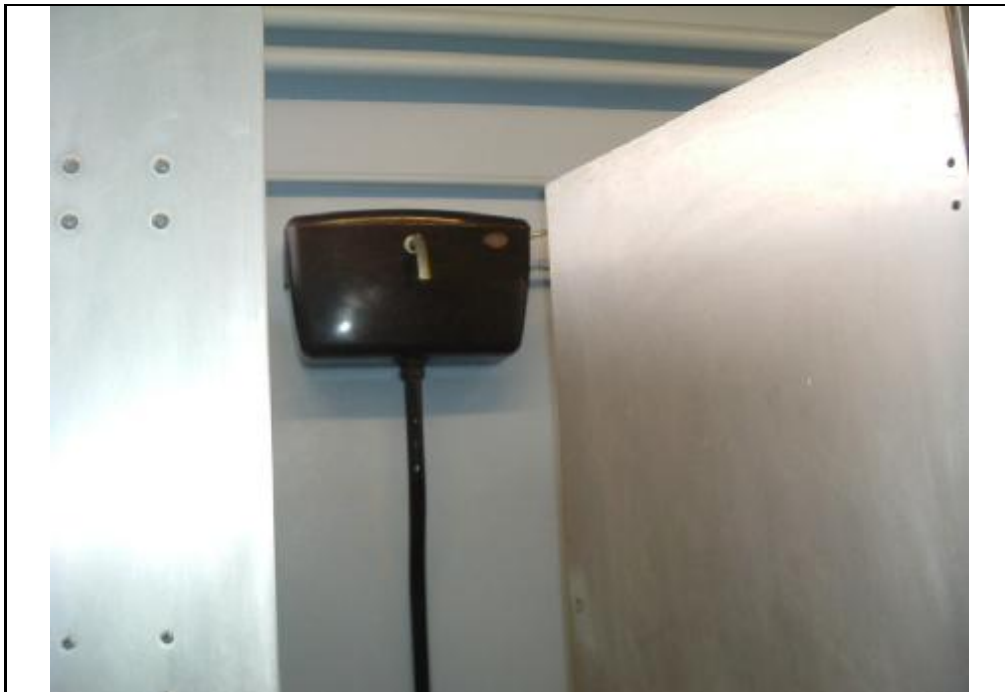
Material Risk Score: 4
Material Risk Band: Very Low Risk
Priority Risk Score: 3

Material Comments: Asbestos Toilet Cisterns (x5)

Action: Label and Manage

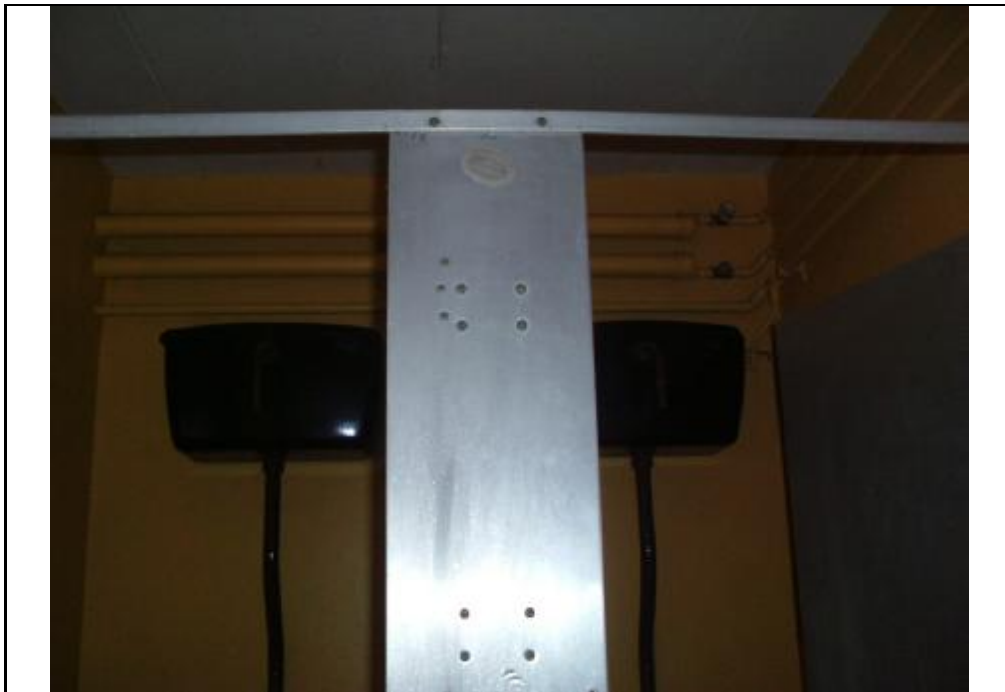
Material Risk Score: 4
Material Risk Band: Very Low Risk
Priority Risk Score: 3

Material Comments: Asbestos Toilet Cistern (x2)

Action: Label and Manage

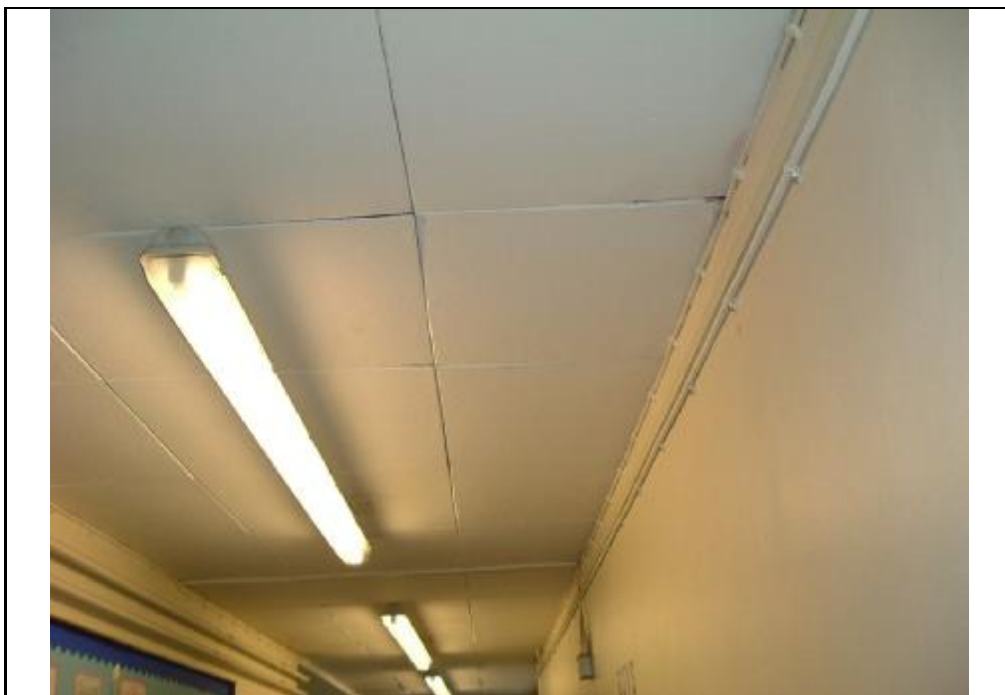
Material Risk Score: 6
Material Risk Band: Low Risk
Priority Risk Score: 2

Material Comments: Asbestos Paper (ceiling tile linings)

Action: Label and Manage

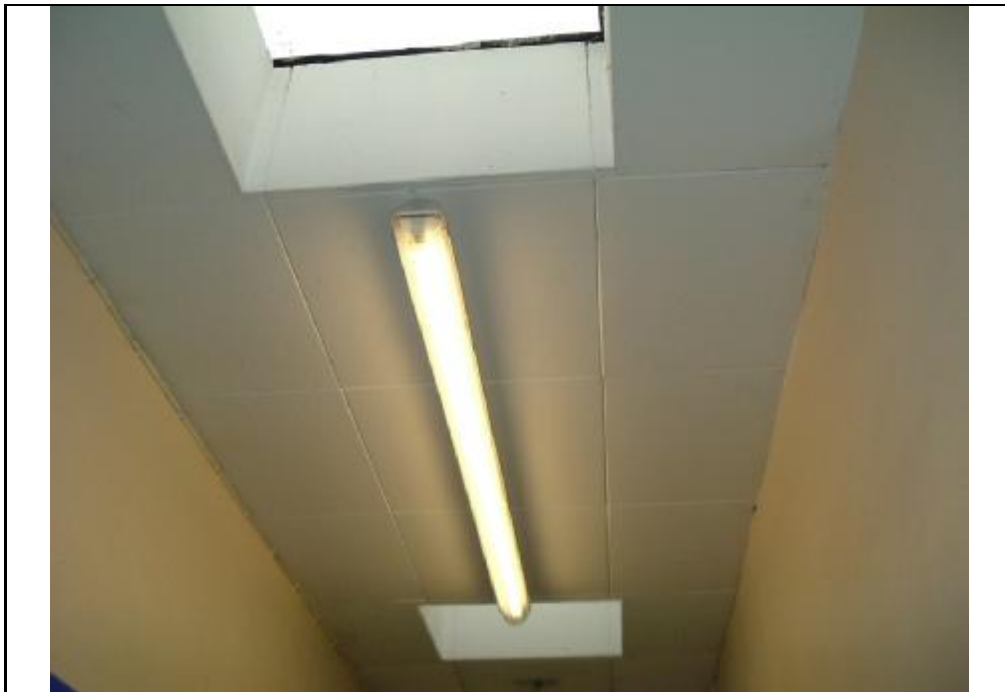
Material Risk Score: 8
Material Risk Band: Medium Risk
Priority Risk Score: 2

Material Comments: Asbestos Paper (ceiling tile linings, also present to skylights)

Action: Label and Manage

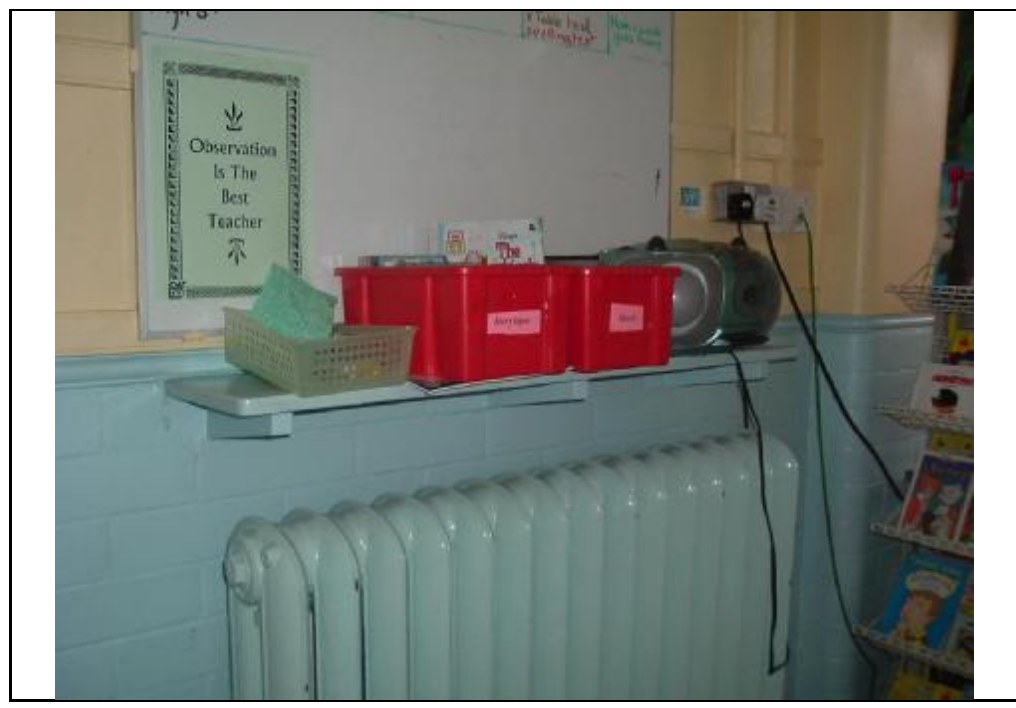
Asbestos ? Yes
Date: 25 January 2006
Next Inspection: 25 January 2007
Material Risk Score: 4
Material Risk Band: Very Low Risk
Priority Risk Score: 8

Material Comments: Asbestos Cement Board (shelves to wall x2)

Action: Requires Encapsulation and Manage

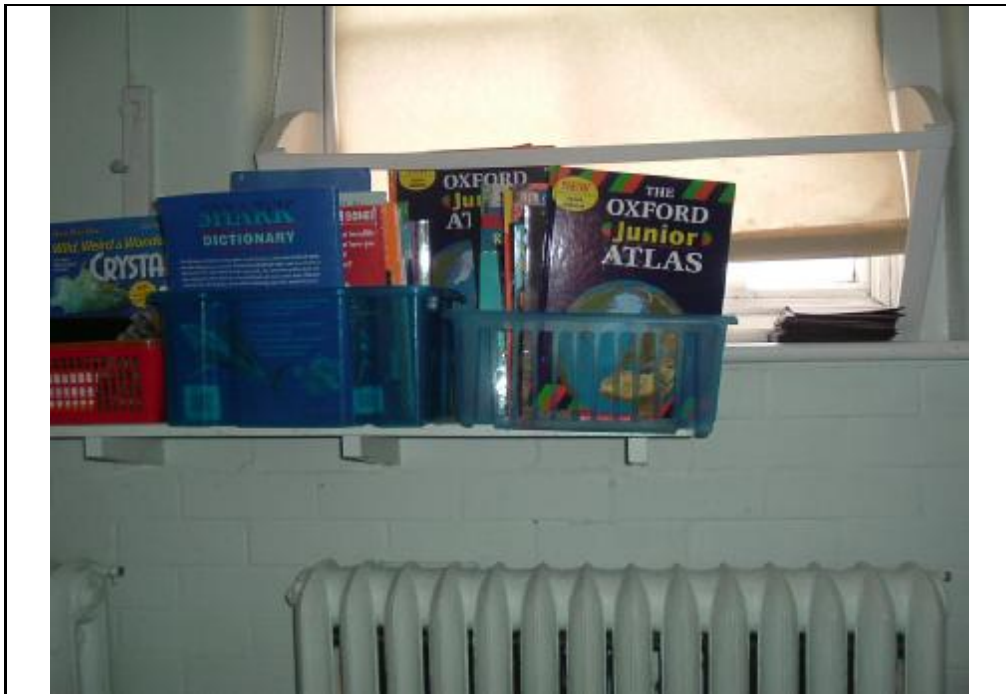
Material Risk Score: 5
 Material Risk Band: Low Risk
 Priority Risk Score: 8

Material Comments: Asbestos Cement Board (shelves to wall x2)

Action: Requires Encapsulation, Label and Manage

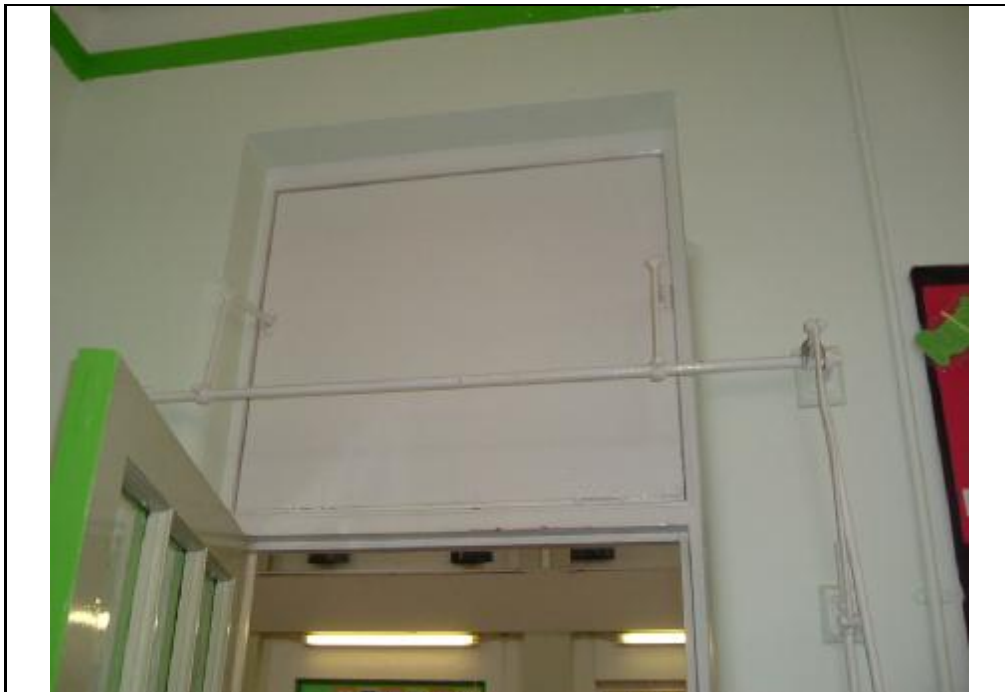
Material Comments: Asbestos Board (infill panel above door)

Action: Requires Encapsulation, Label and Manage

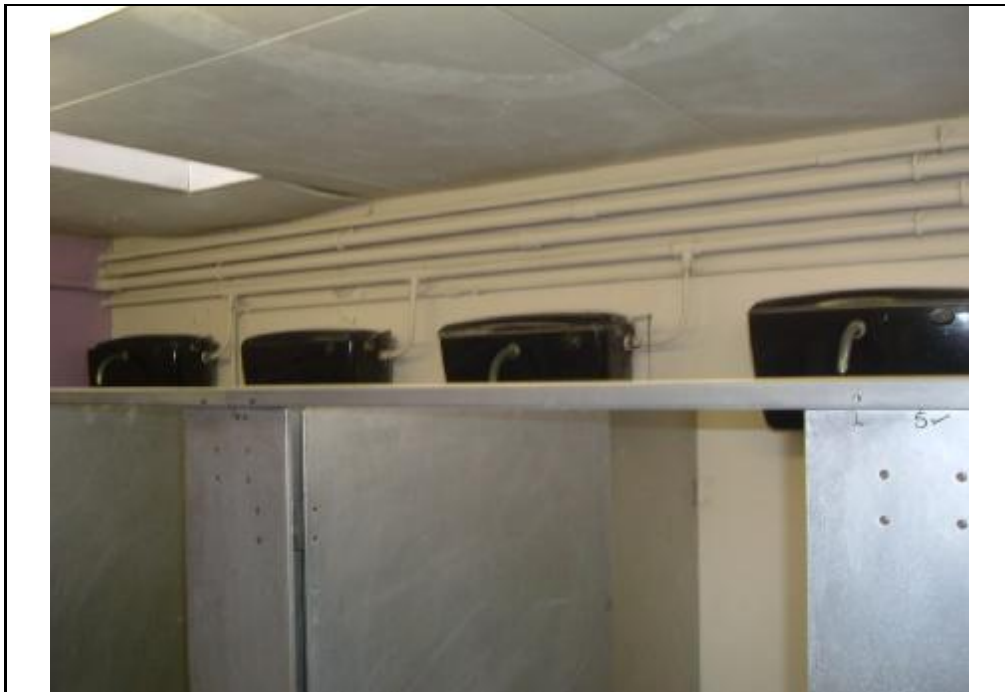
Material Comments: Asbestos Toilet Cisterns (x5)

Action: Label and Manage

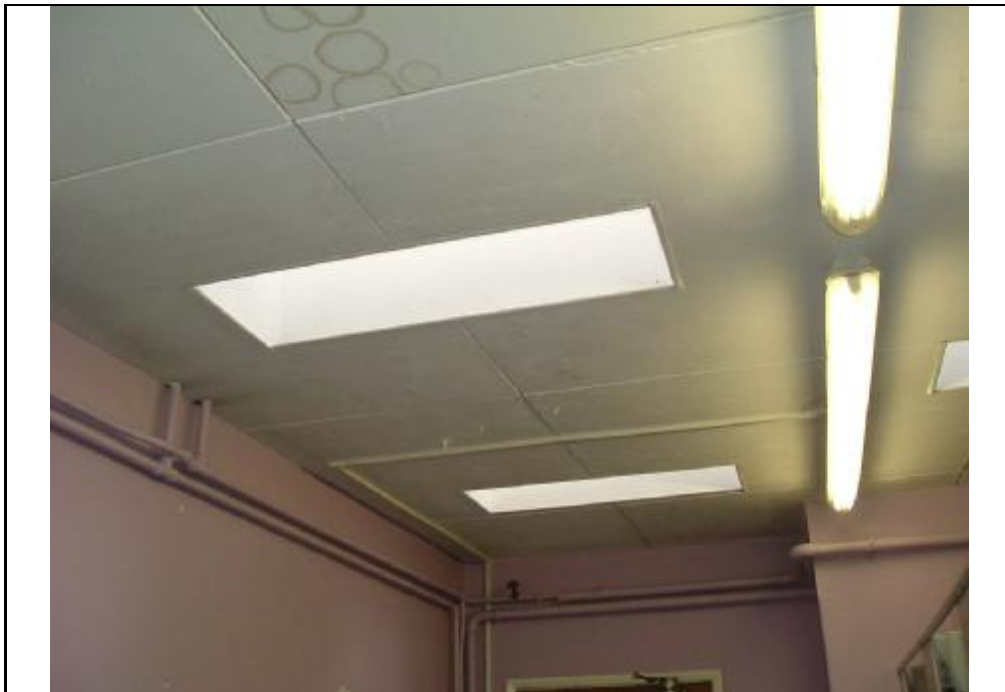
Material Risk Score: 6
Material Risk Band: Low Risk
Priority Risk Score: 2

Material Comments: Asbestos Paper (ceiling tile linings, also present in skylights and in female toilet 2)

Action: Label and Manage

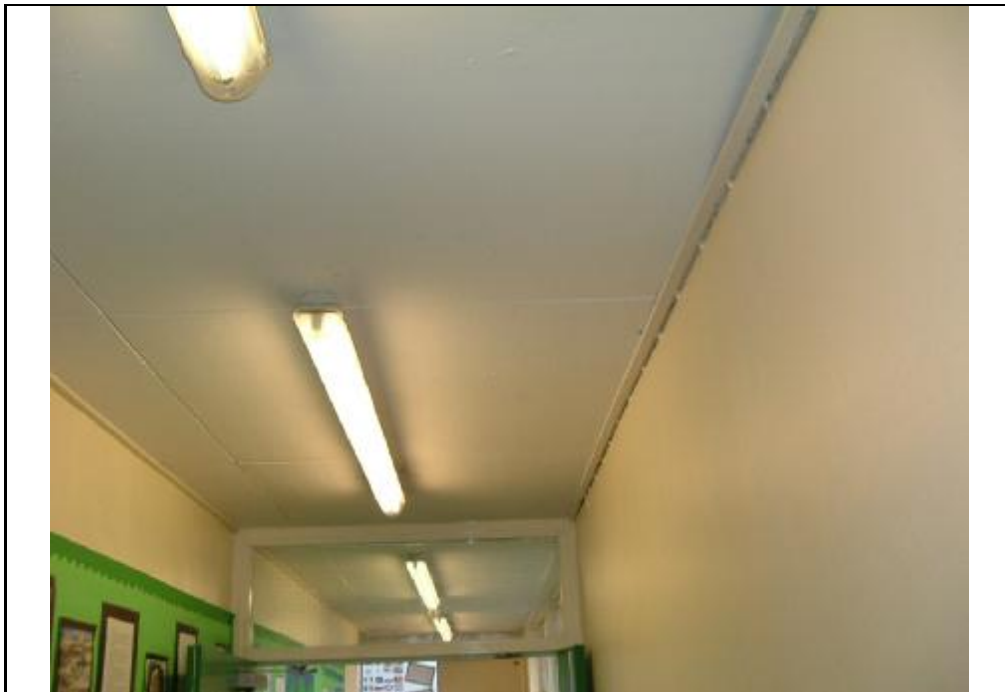
Material Comments: Asbestos Paper - (ceiling tile linings, also present in skylights)

Action: Label and Manage

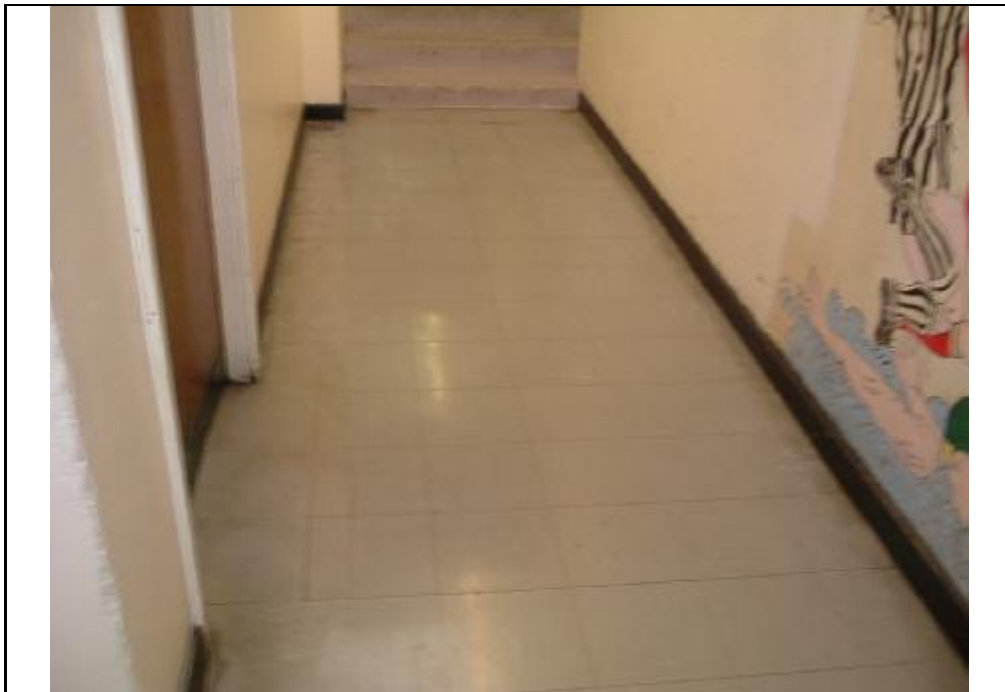
Asbestos Floor Tiles

Action: Manage only

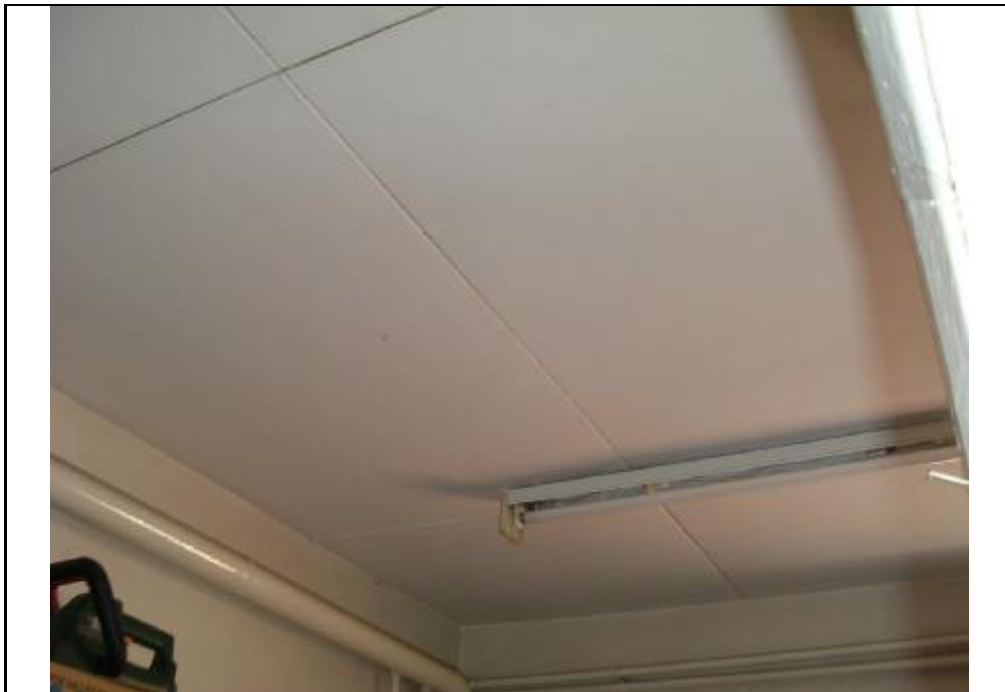
Material Risk Score: 6
Material Risk Band: Low Risk
Priority Risk Score: 3

Material Comments: Asbestos Paper (ceiling tile linings)

Action: Label and Manage

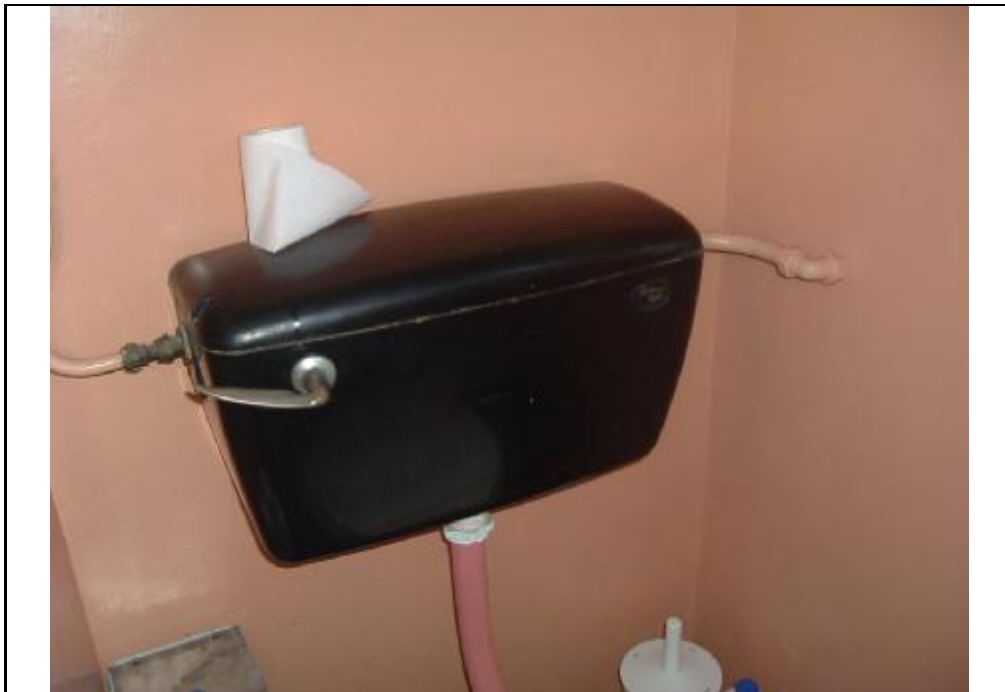
Material Comments: Asbestos Toilet Cistern

Action: Label and Manage

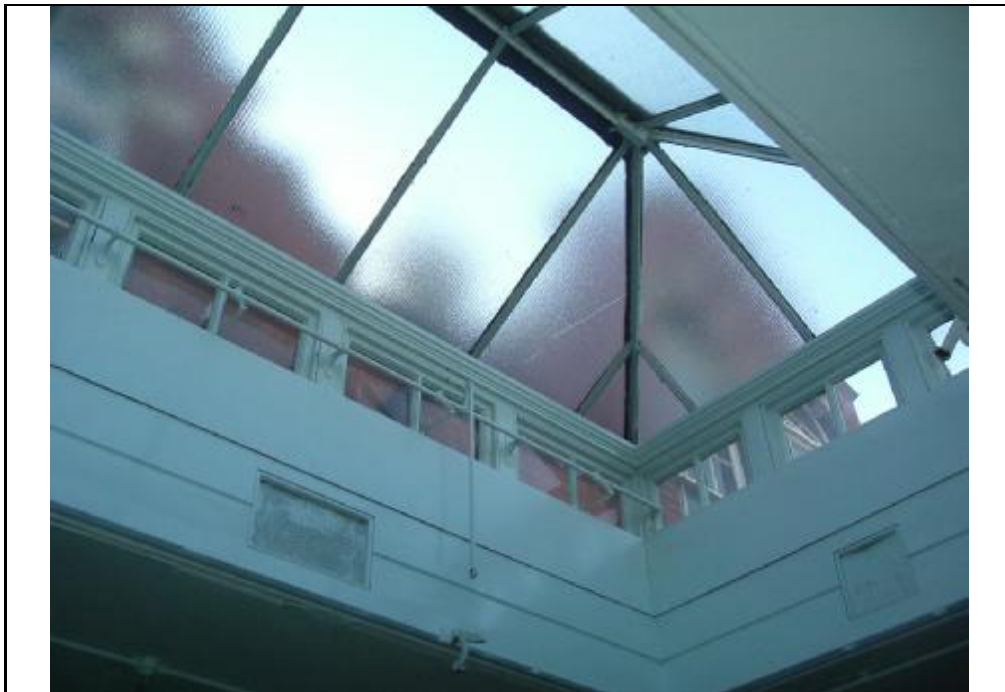
Material Risk Score: 6
Material Risk Band: Low Risk
Priority Risk Score: 3

Material Comments: Asbestos Rope (skylight glazing rope)

Action: Manage only

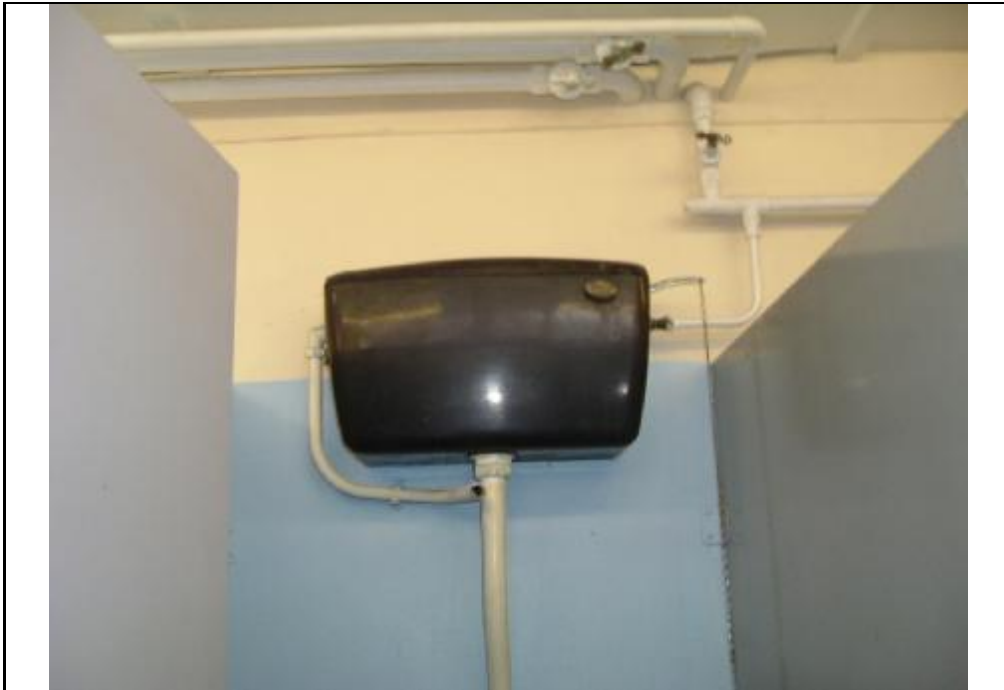
Asbestos Toilet Cisterns (x4)

Action: Label and Manage

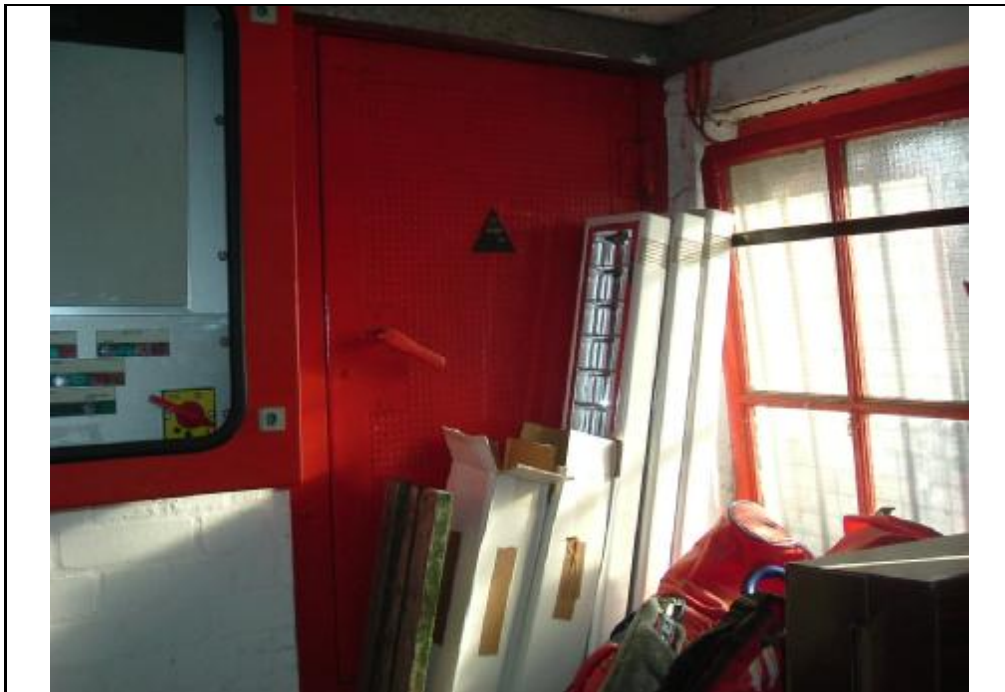
Material Comments: Asbestos Durasteel (door to oil store)

Action: Requires Encapsulation, Label and Manage

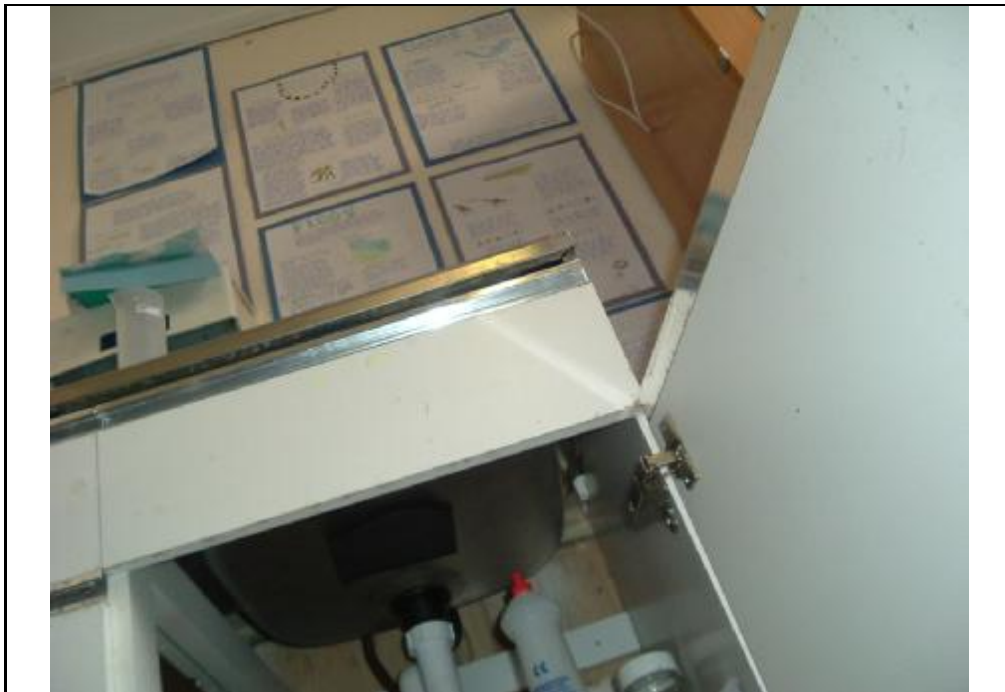
Material Risk Score: 0
Material Risk Band: NADIS
Priority Risk Score: N/A

Material Comments: NADIS - Bitumen Pad (beneath sink)

Action: No Action Required

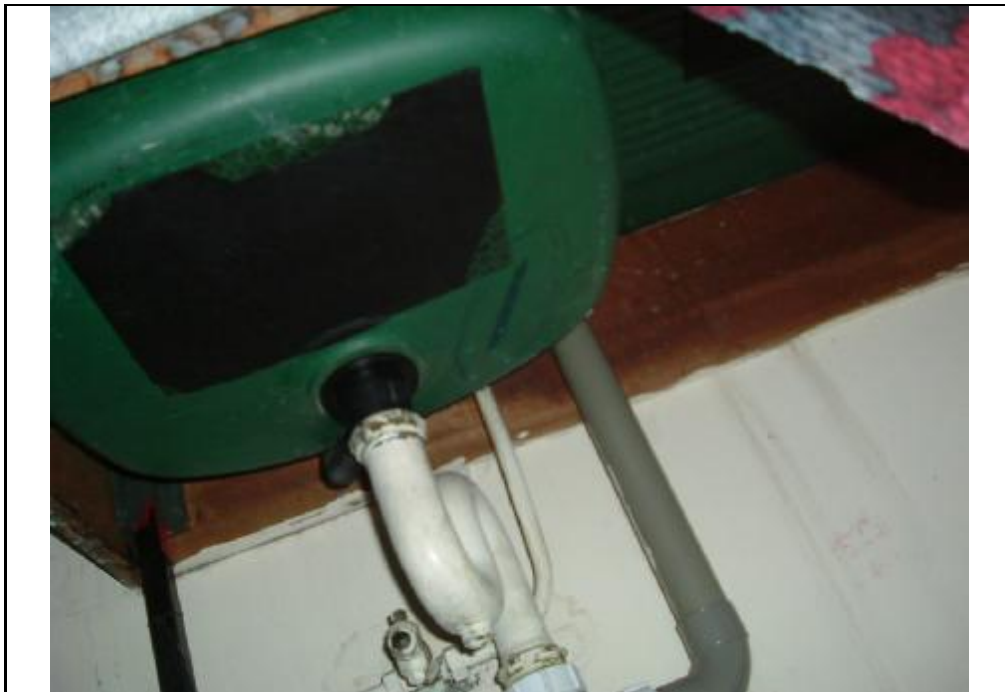
Material Comments: Asbestos Bitumen Pad (beneath sink)

Action: Label and Manage

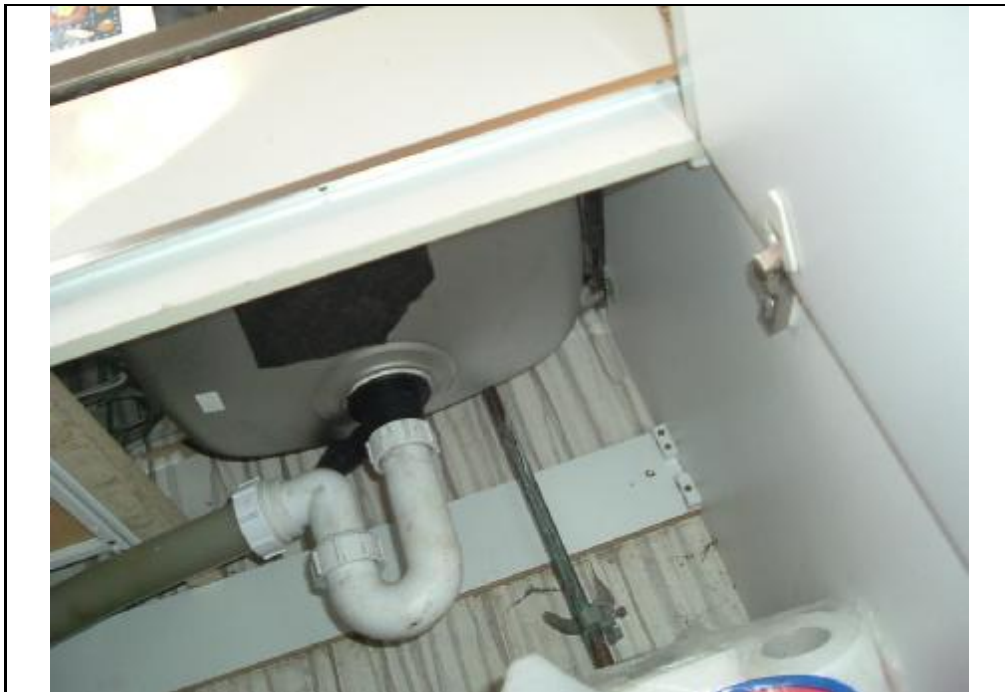
Material Comments: NADIS - Bitumen Pad (beneath sink)

Action: No Action Required

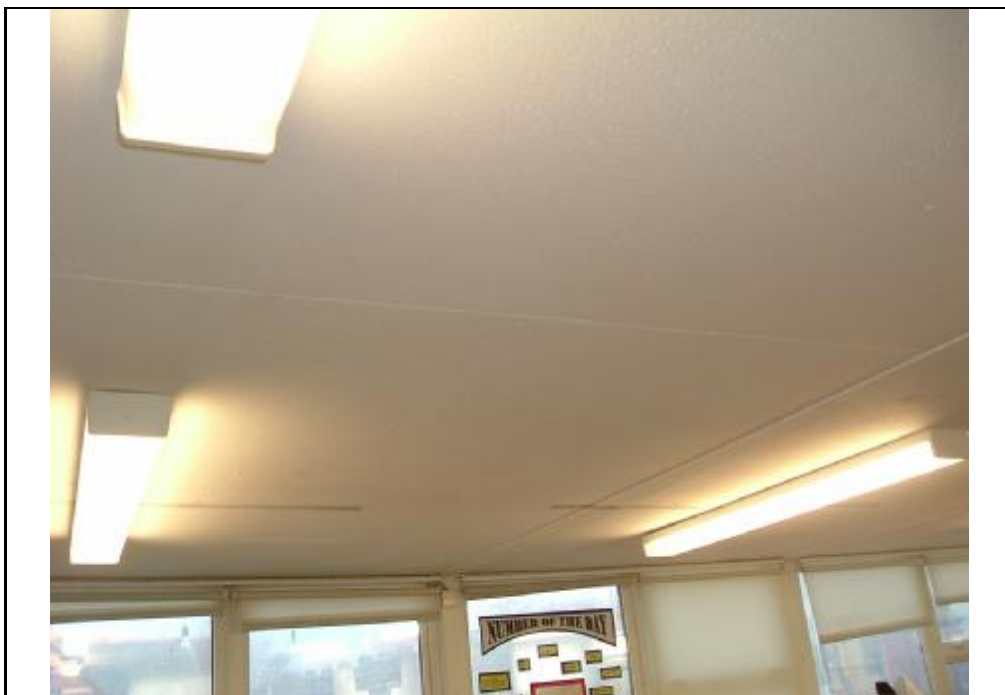
Material Risk Score: 4
Material Risk Band: Very Low Risk
Priority Risk Score: 5

Material Comments: Asbestos Textured Coating (ceiling also presnt in store)

Action: Label and Manage

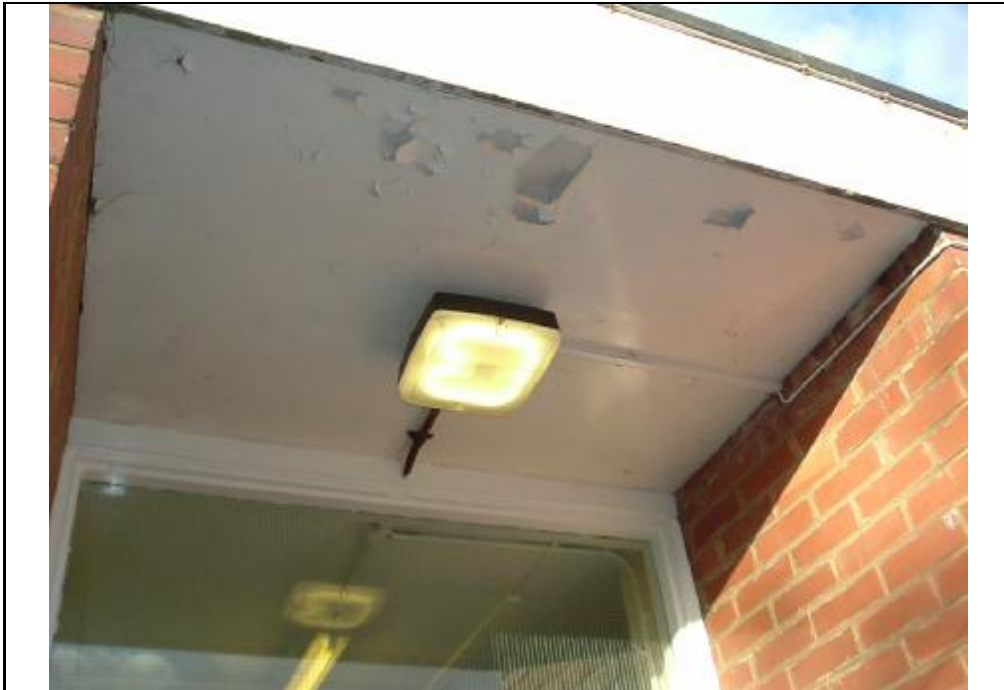
Asbestos Board (porch ceiling panel)

Action: Requires Encapsulation, Label and Manage

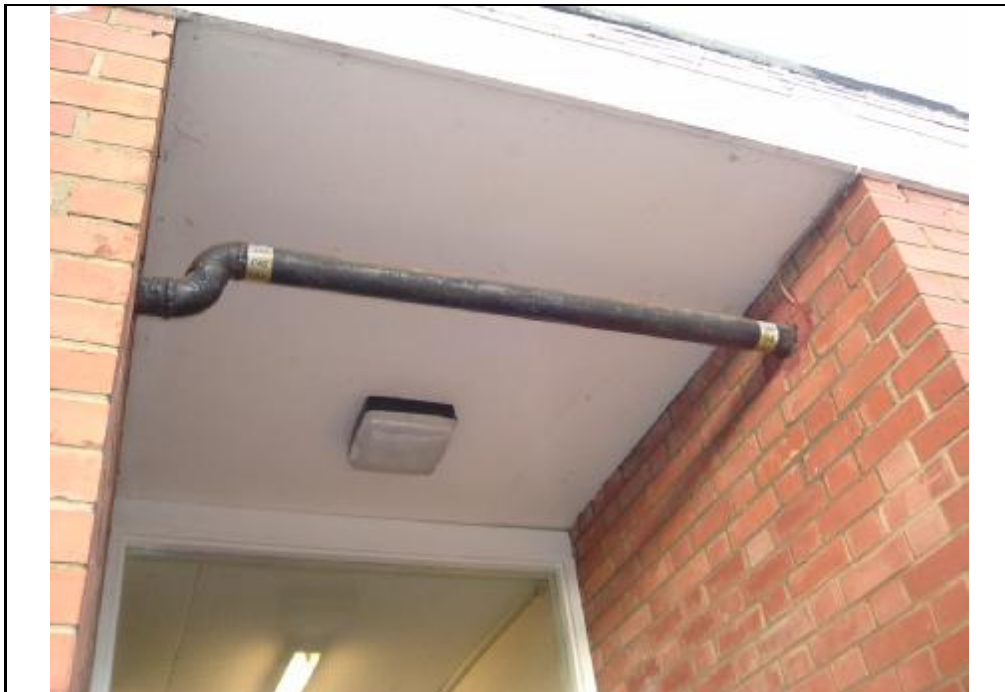
Material Risk Score: 6
Material Risk Band: Low Risk
Priority Risk Score: N/A

Material Comments: Asbestos Board (porch ceiling panel)

Action: Requires Encapsulation, Label and Manage

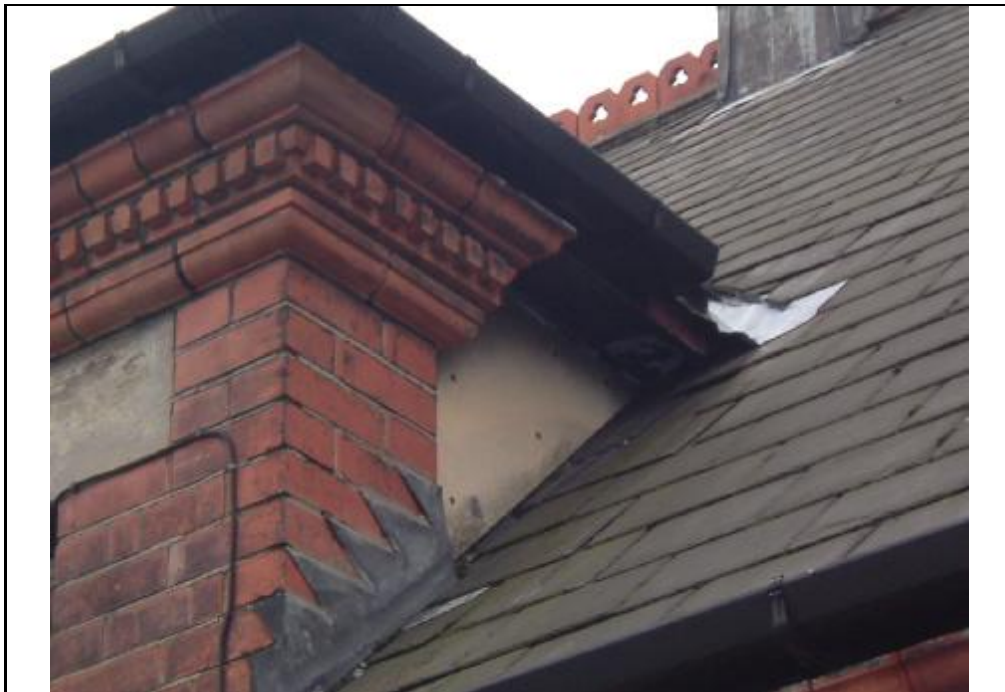
Material Risk Score: 4
Material Risk Band: Very Low Risk
Priority Risk Score: 1

Material Comments: Asbestos Cement Board (infill panels at roof level x8)

Action: Manage only

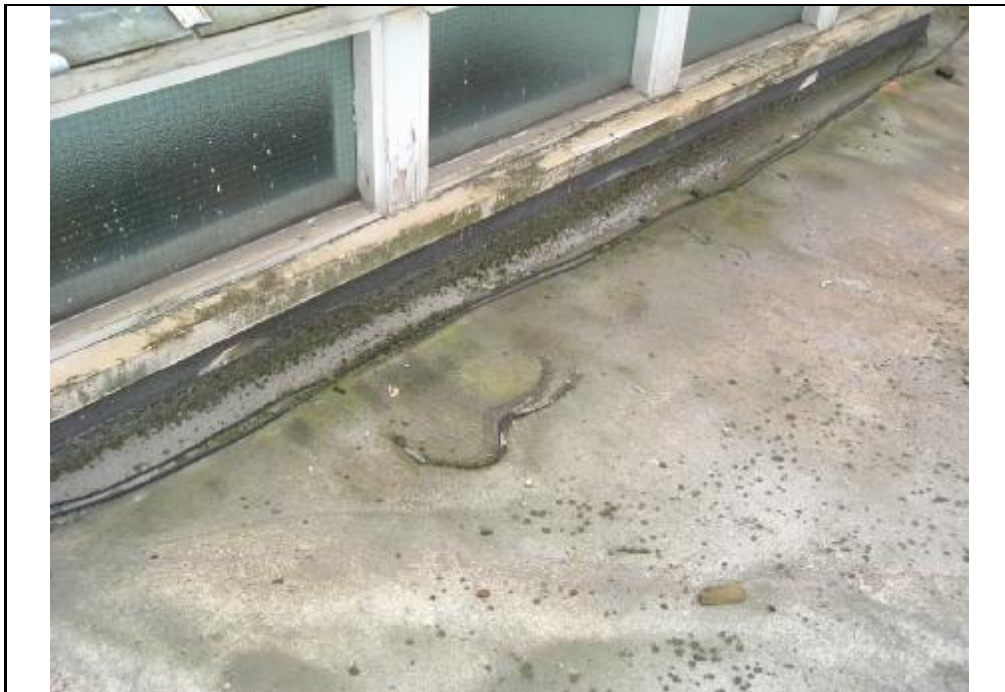
Material Risk Score: 9
Material Risk Band: Medium Risk
Priority Risk Score: N/A

Material Comments: Asbestos Debris (rope, loose on flat roof)

Action: Requires Removal
