**Phase I Geo-Environmental Assessment Report**

Selwyn Primary School  
Cavendish Road  
Highams Park  
London  
E4 9NG

**EPS Project:** UK13.1429  
**Report Status** Final  
**Date Issued:** 22<sup>nd</sup> January 2014

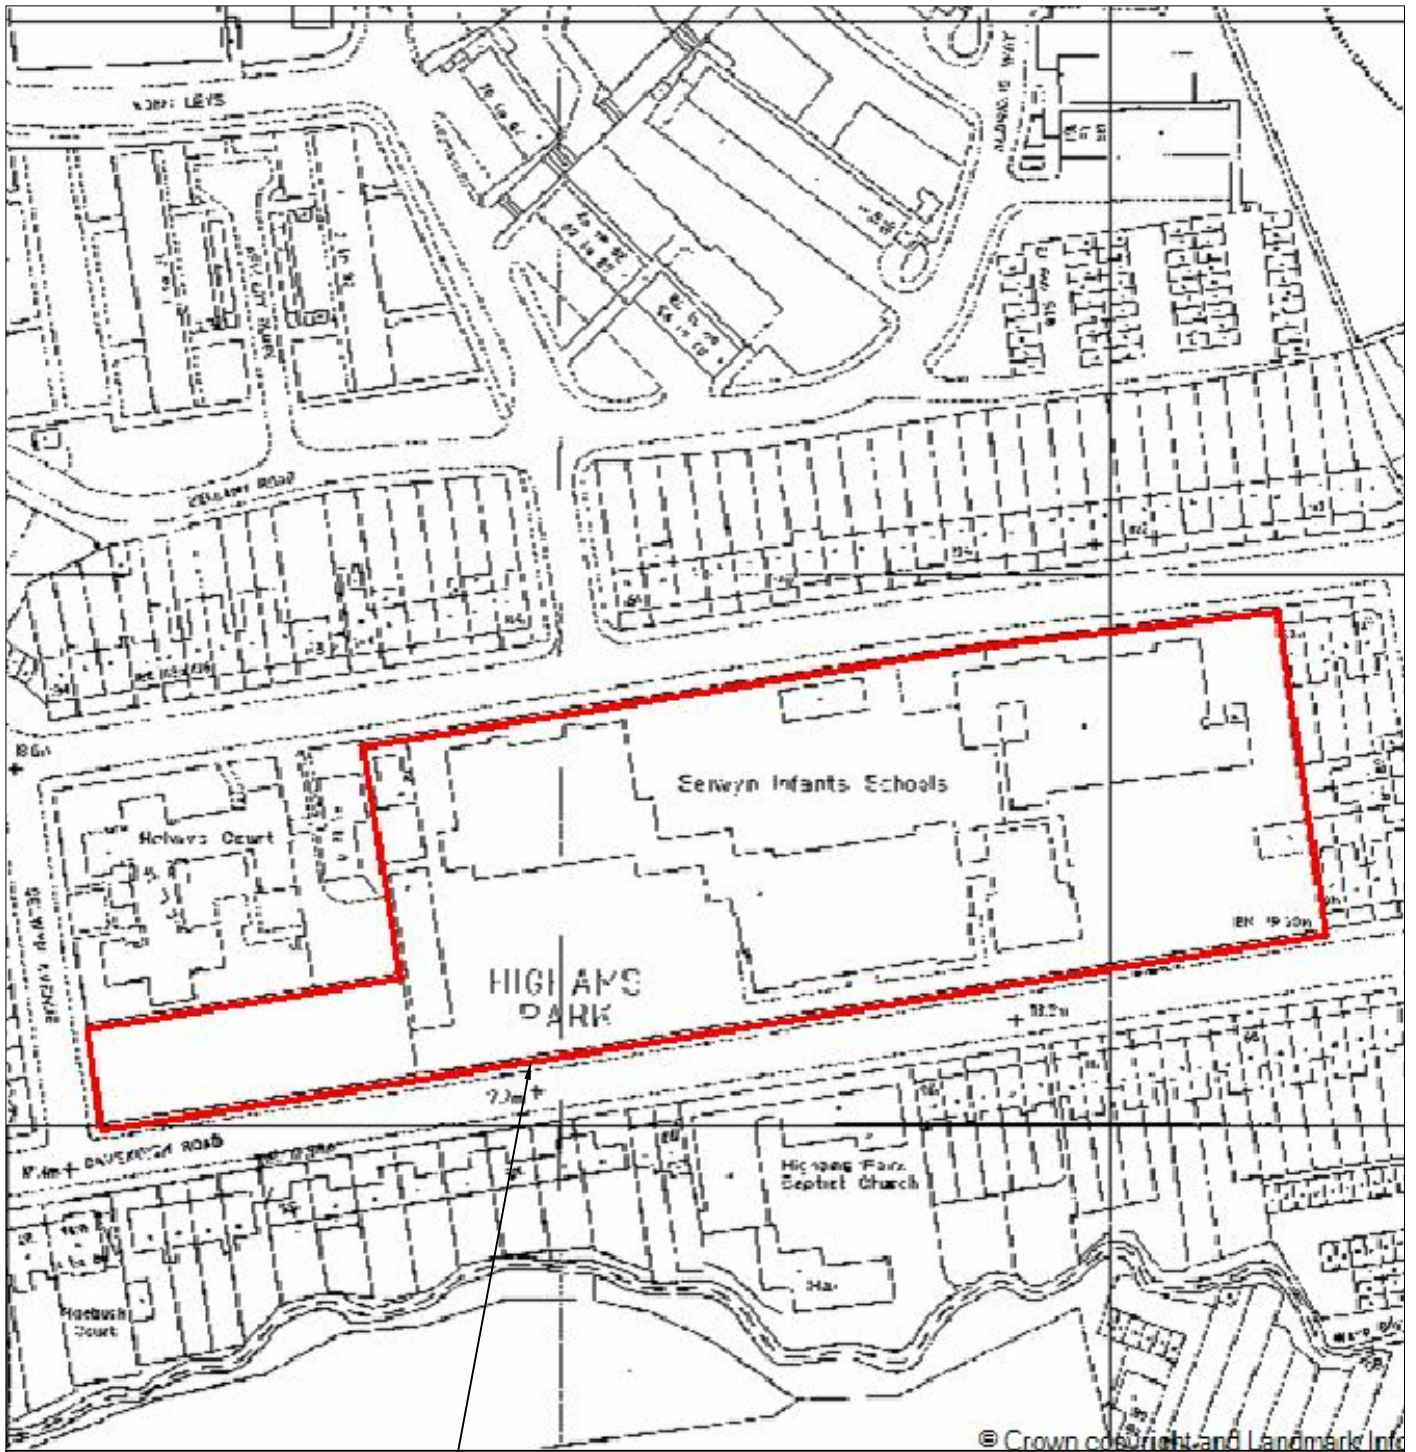
**Title:** Current Site Layout Plan

Metal fencing surrounds the school, with the main buildings occupying north eastern, north western and central southern areas, with hard play areas and associated play equipment located between them. The existing structures are generally single storey in height with pitched roofs. Helwys Court along with the area of undeveloped land lies beyond the western boundary of the school, with residential properties and their associated gardens lying to the south, north and east.

A plan showing the site location is provided as Figure 1, a current site layout plan is included as Figure 2 and an aerial photograph is included as Figure 3. Selected site photographs are included as Appendix A and relevant extracts of a Landmark Envirocheck report are included as Appendix B.

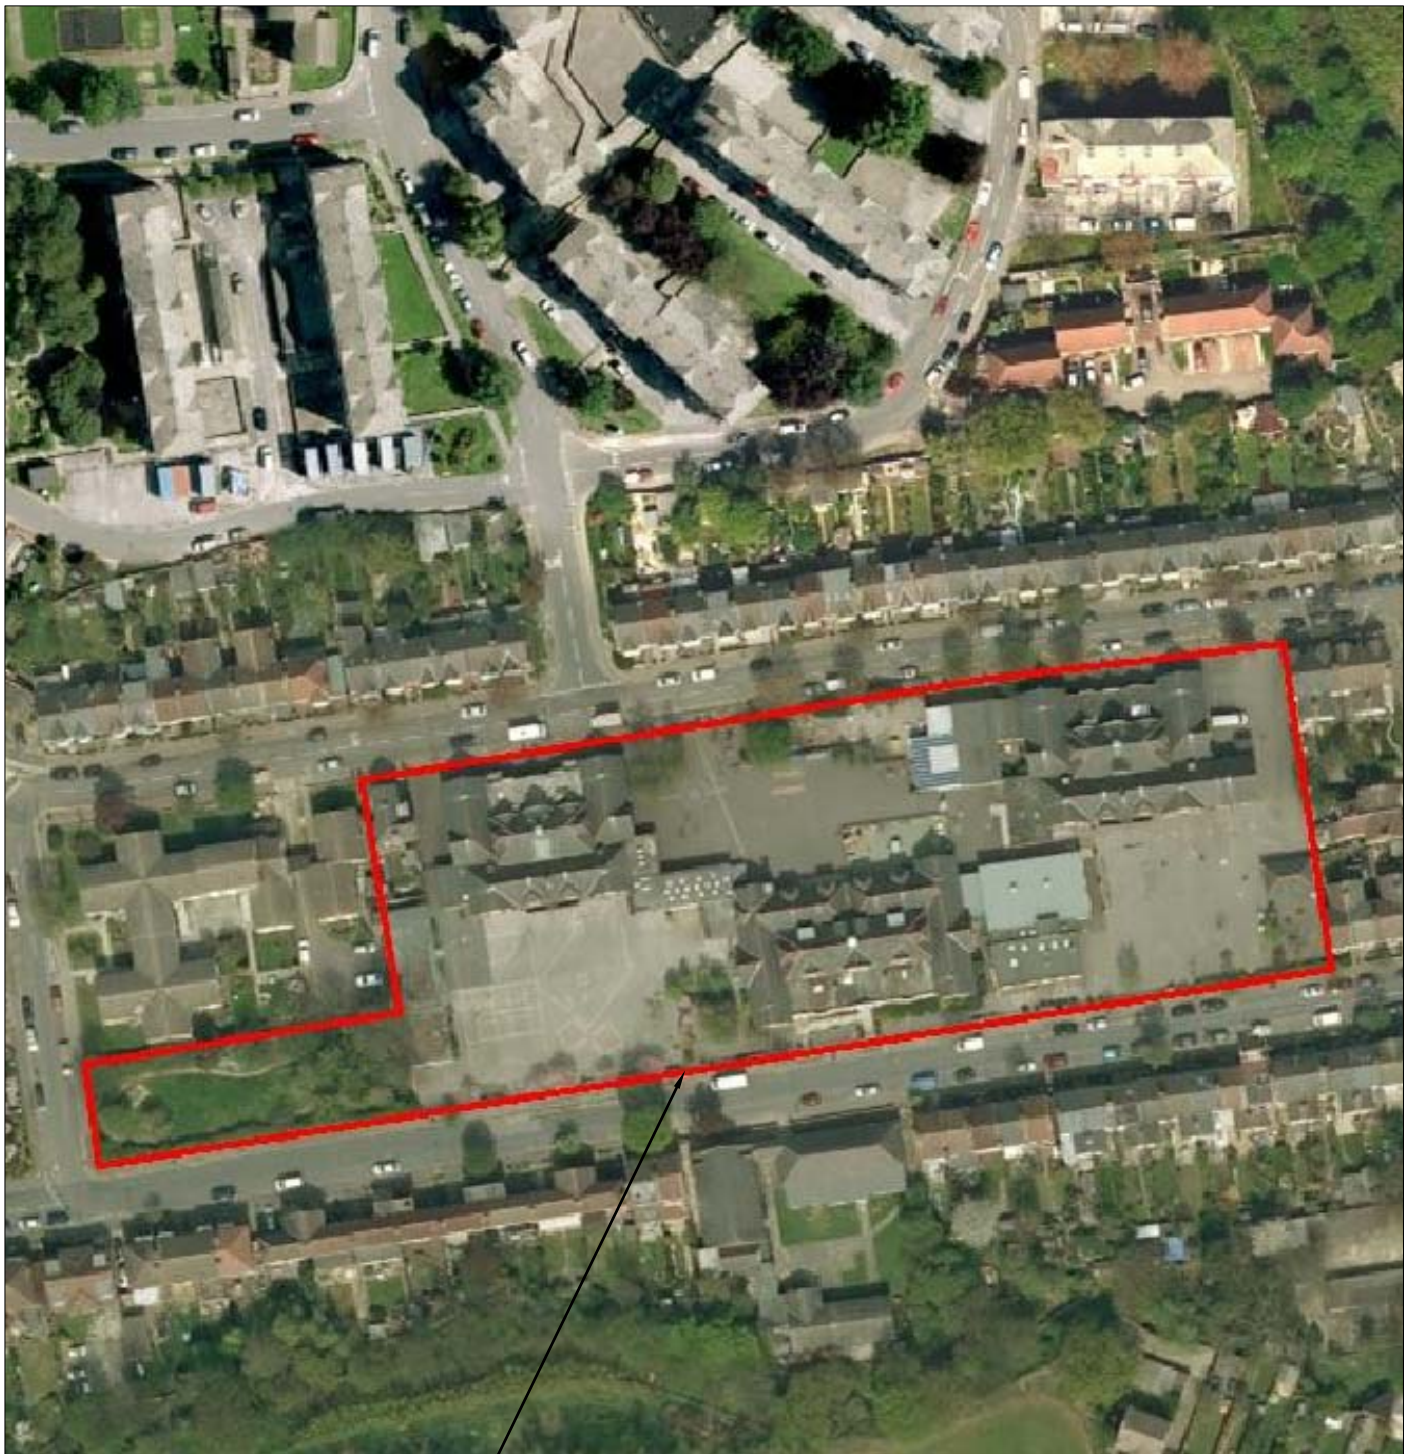
**Title:** Aerial Photograph

Approximate Site Boundary
